Pre-Purchase Inspection - Residential Building Report (Except ACT)

Complies with Australian Standard AS 4349.1- 2007 Inspection of Buildings Part 1:
Pre-Purchase inspections – Residential buildings – Appendix “C”

Account to: Sample report
Phone: Sample
Address: Sydney

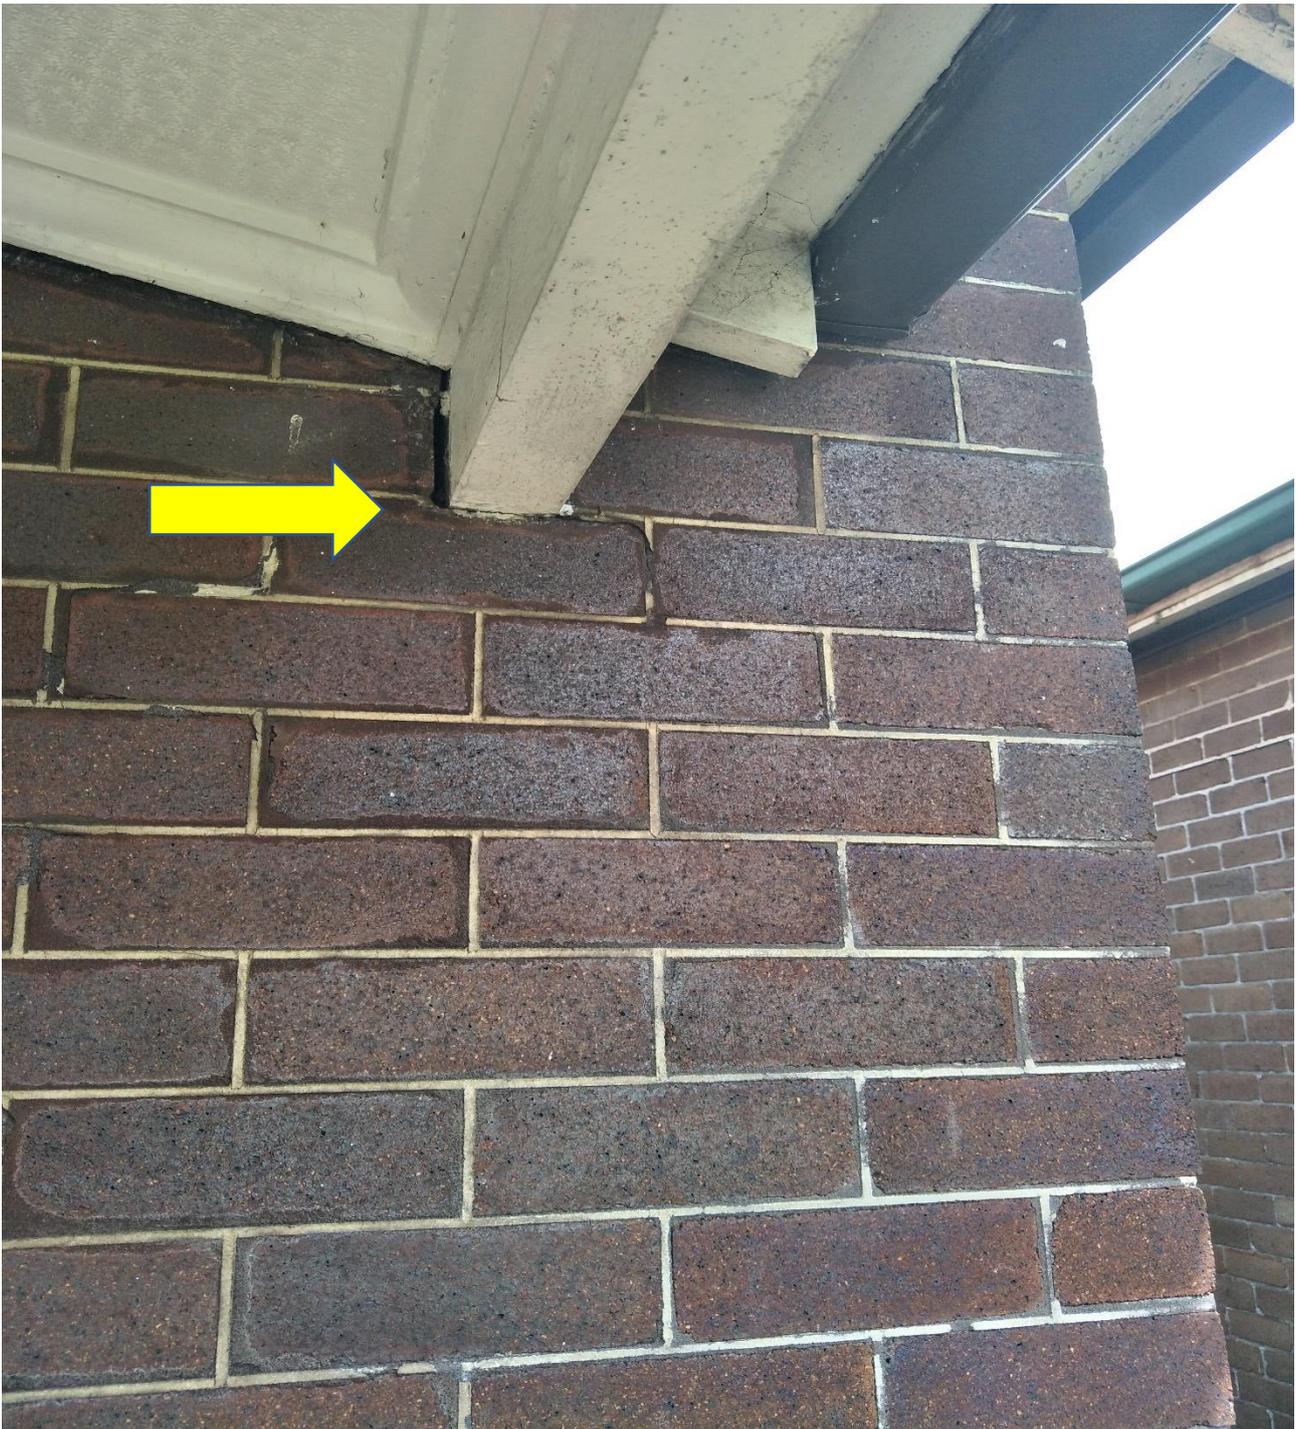
Figure 1 gap noted to timber join point requiring filler as may allow water ingress or vermin. Engage a handy man to fill. Maintenance defect.

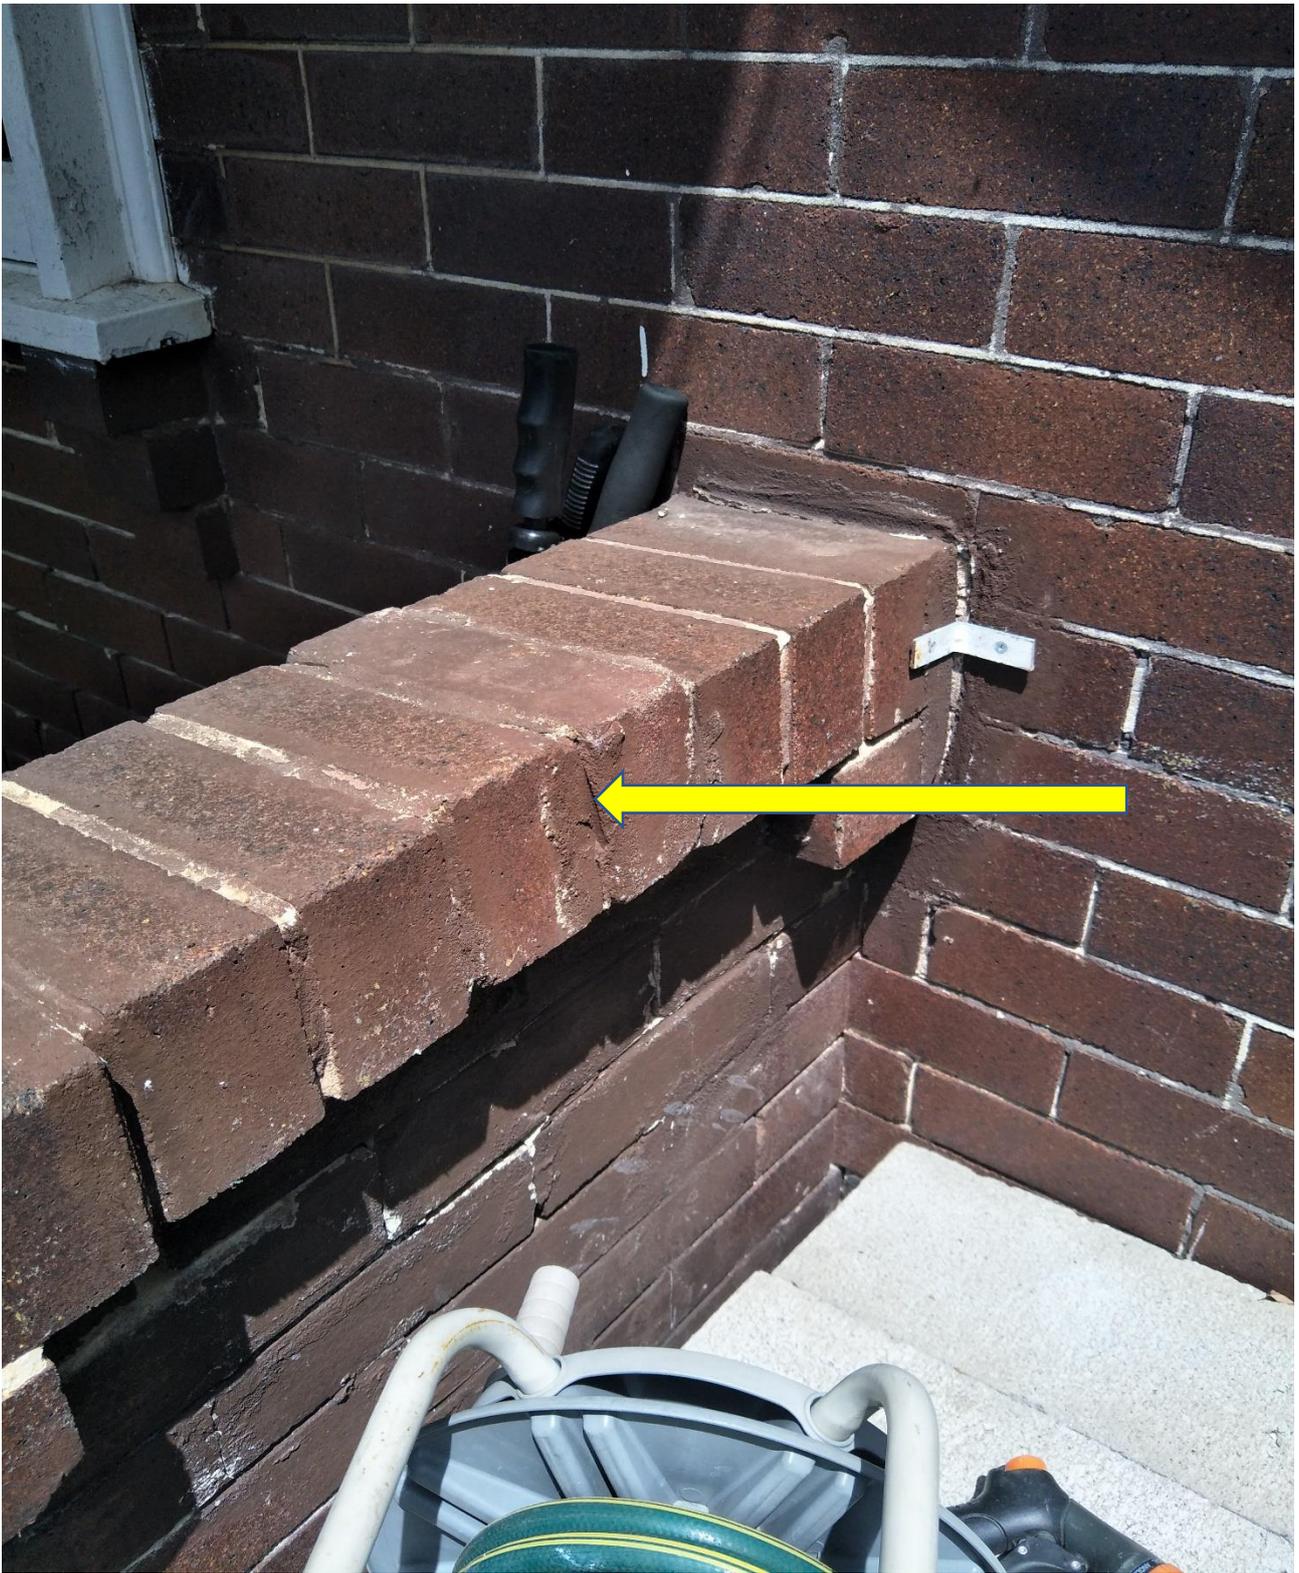
Walls: Defects/Safety Hazards found were exterior bricks require repointing in some locations.

Figure 2 brick work exterior front has been repaired and requires relaying bricks by a licenced brick layer.

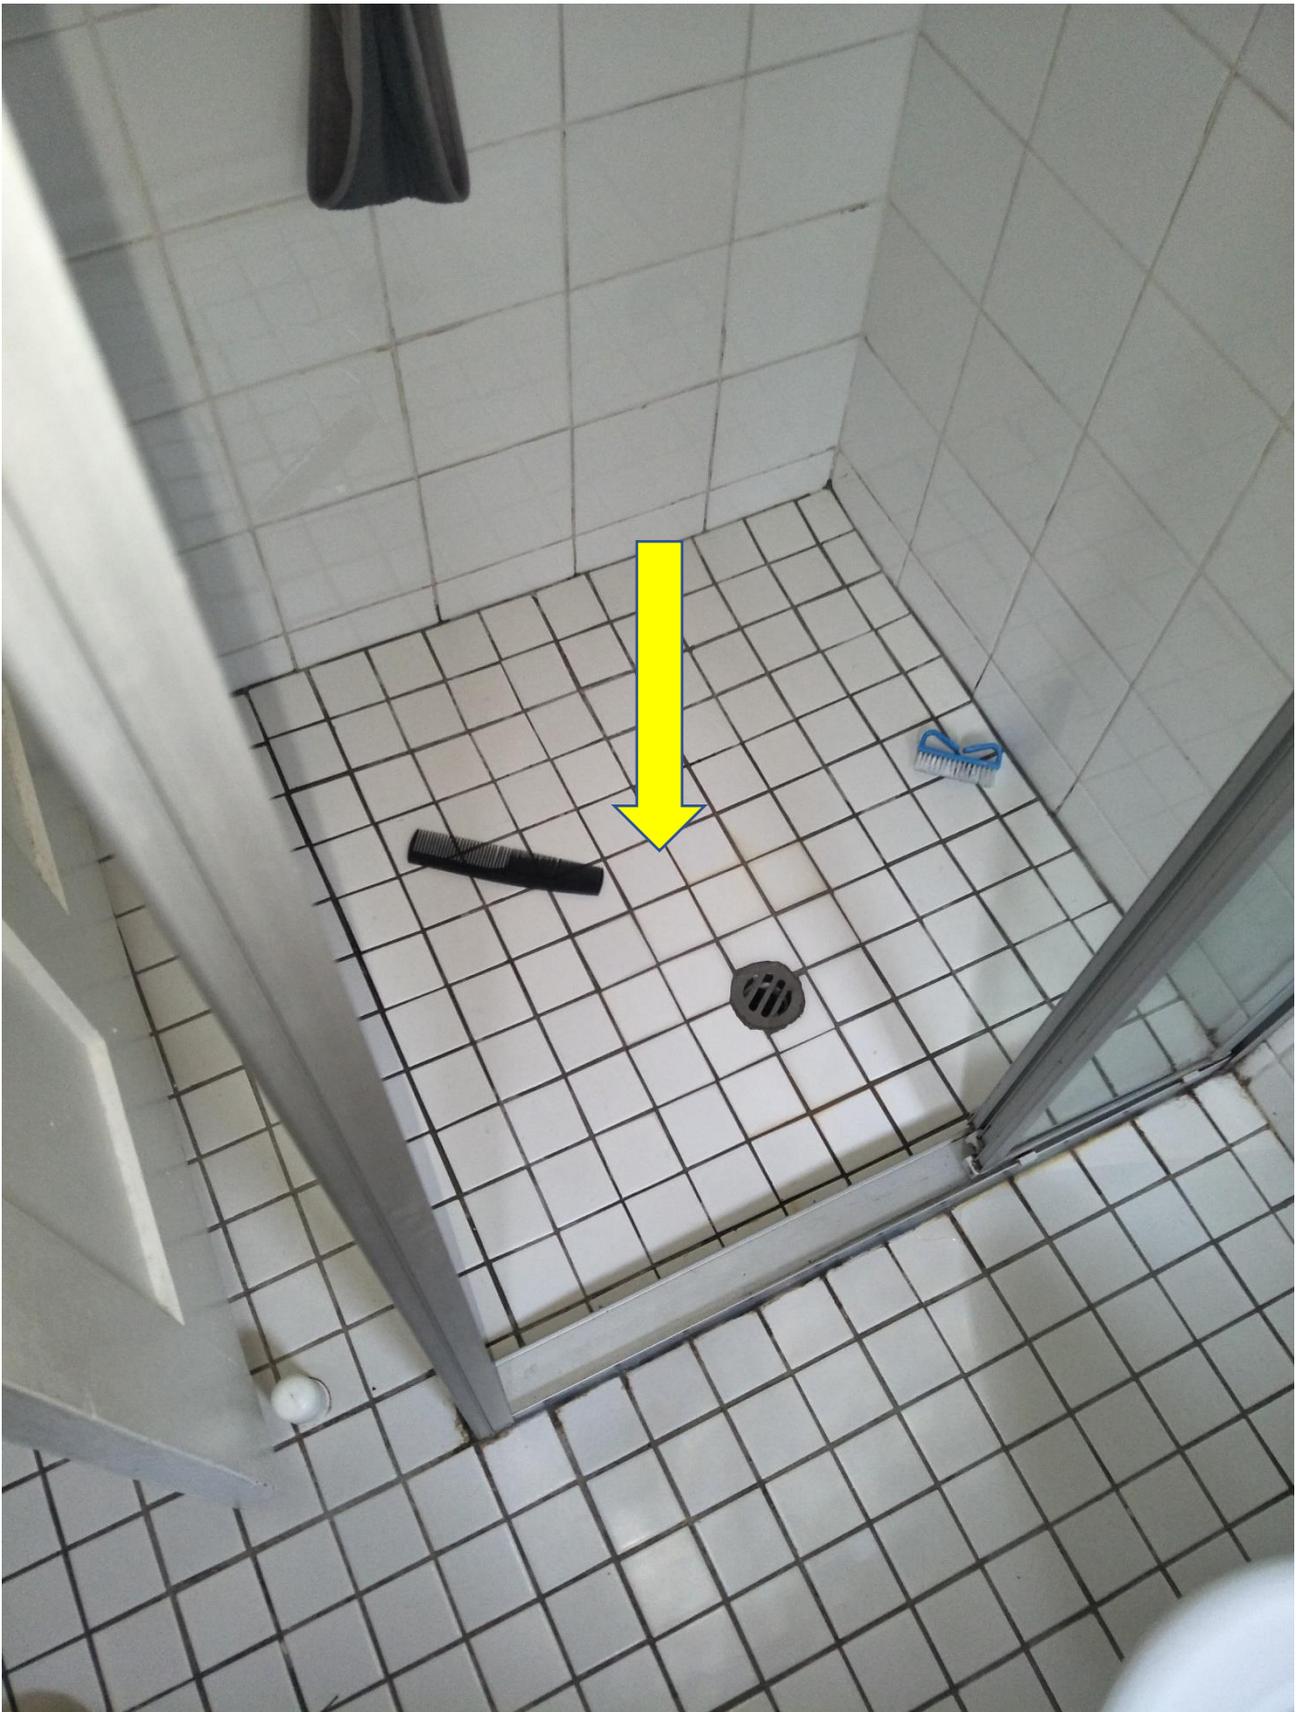
Figure 3 the shower recess requires grouting, Engage a handy man to apply new grout.

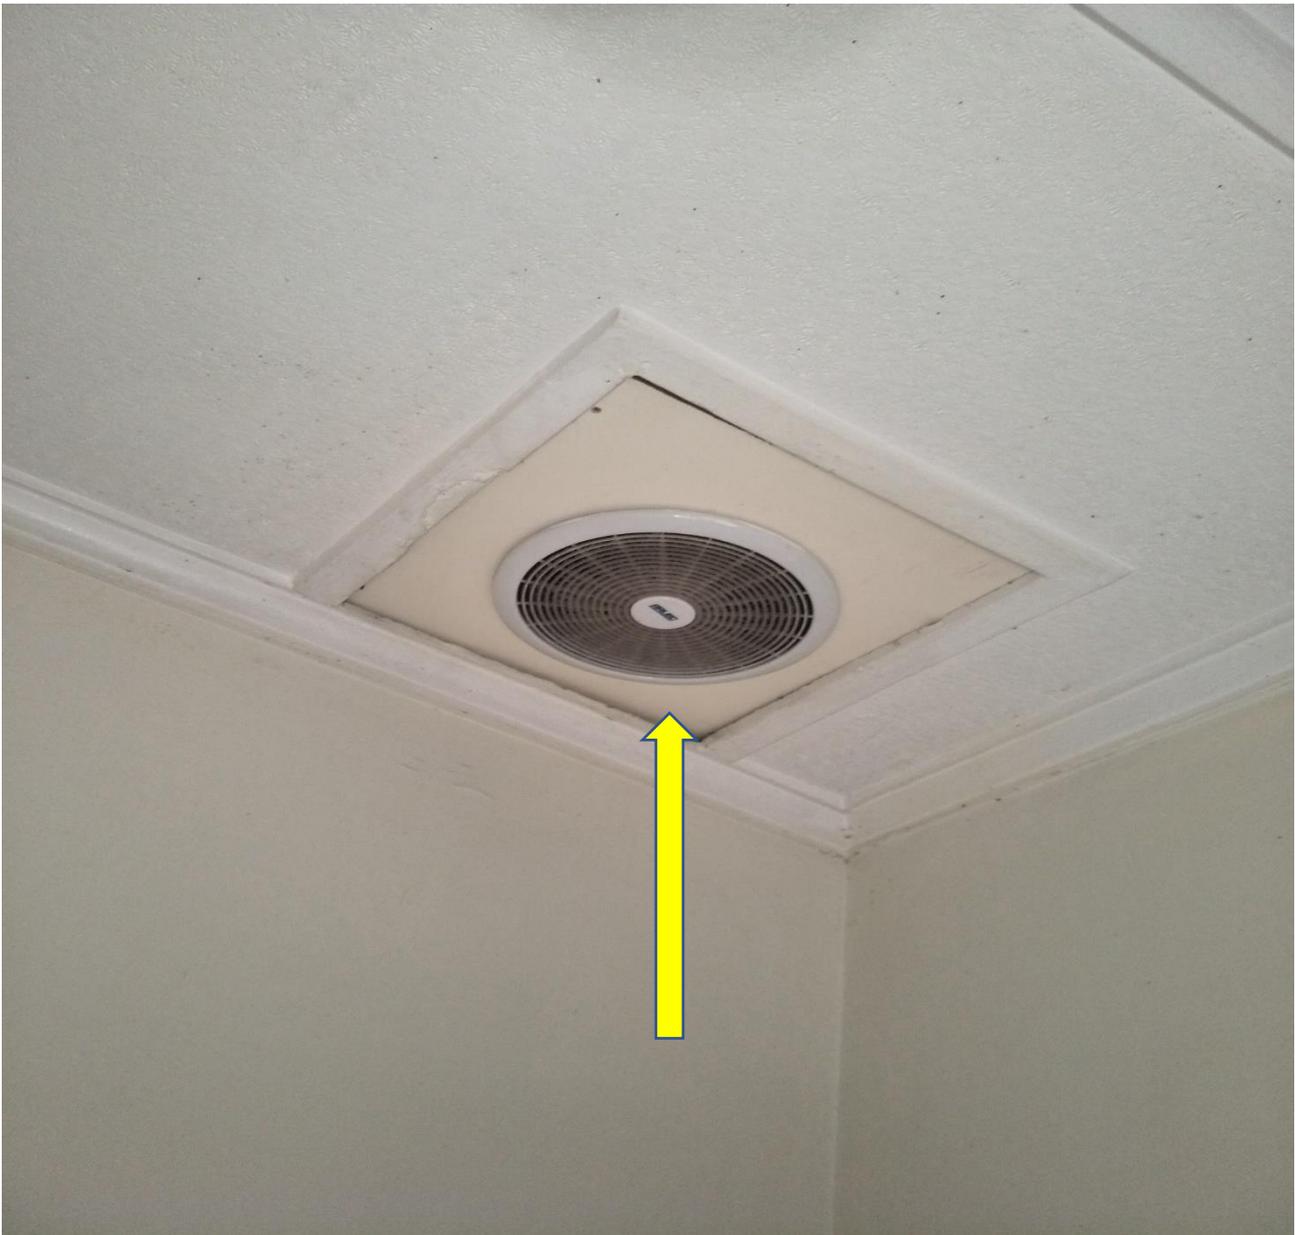
Figure 4 the man hole has an electrical fan in which is a safety hazard. This should be moved into a new location. Engage a licenced electrician to attend to this.

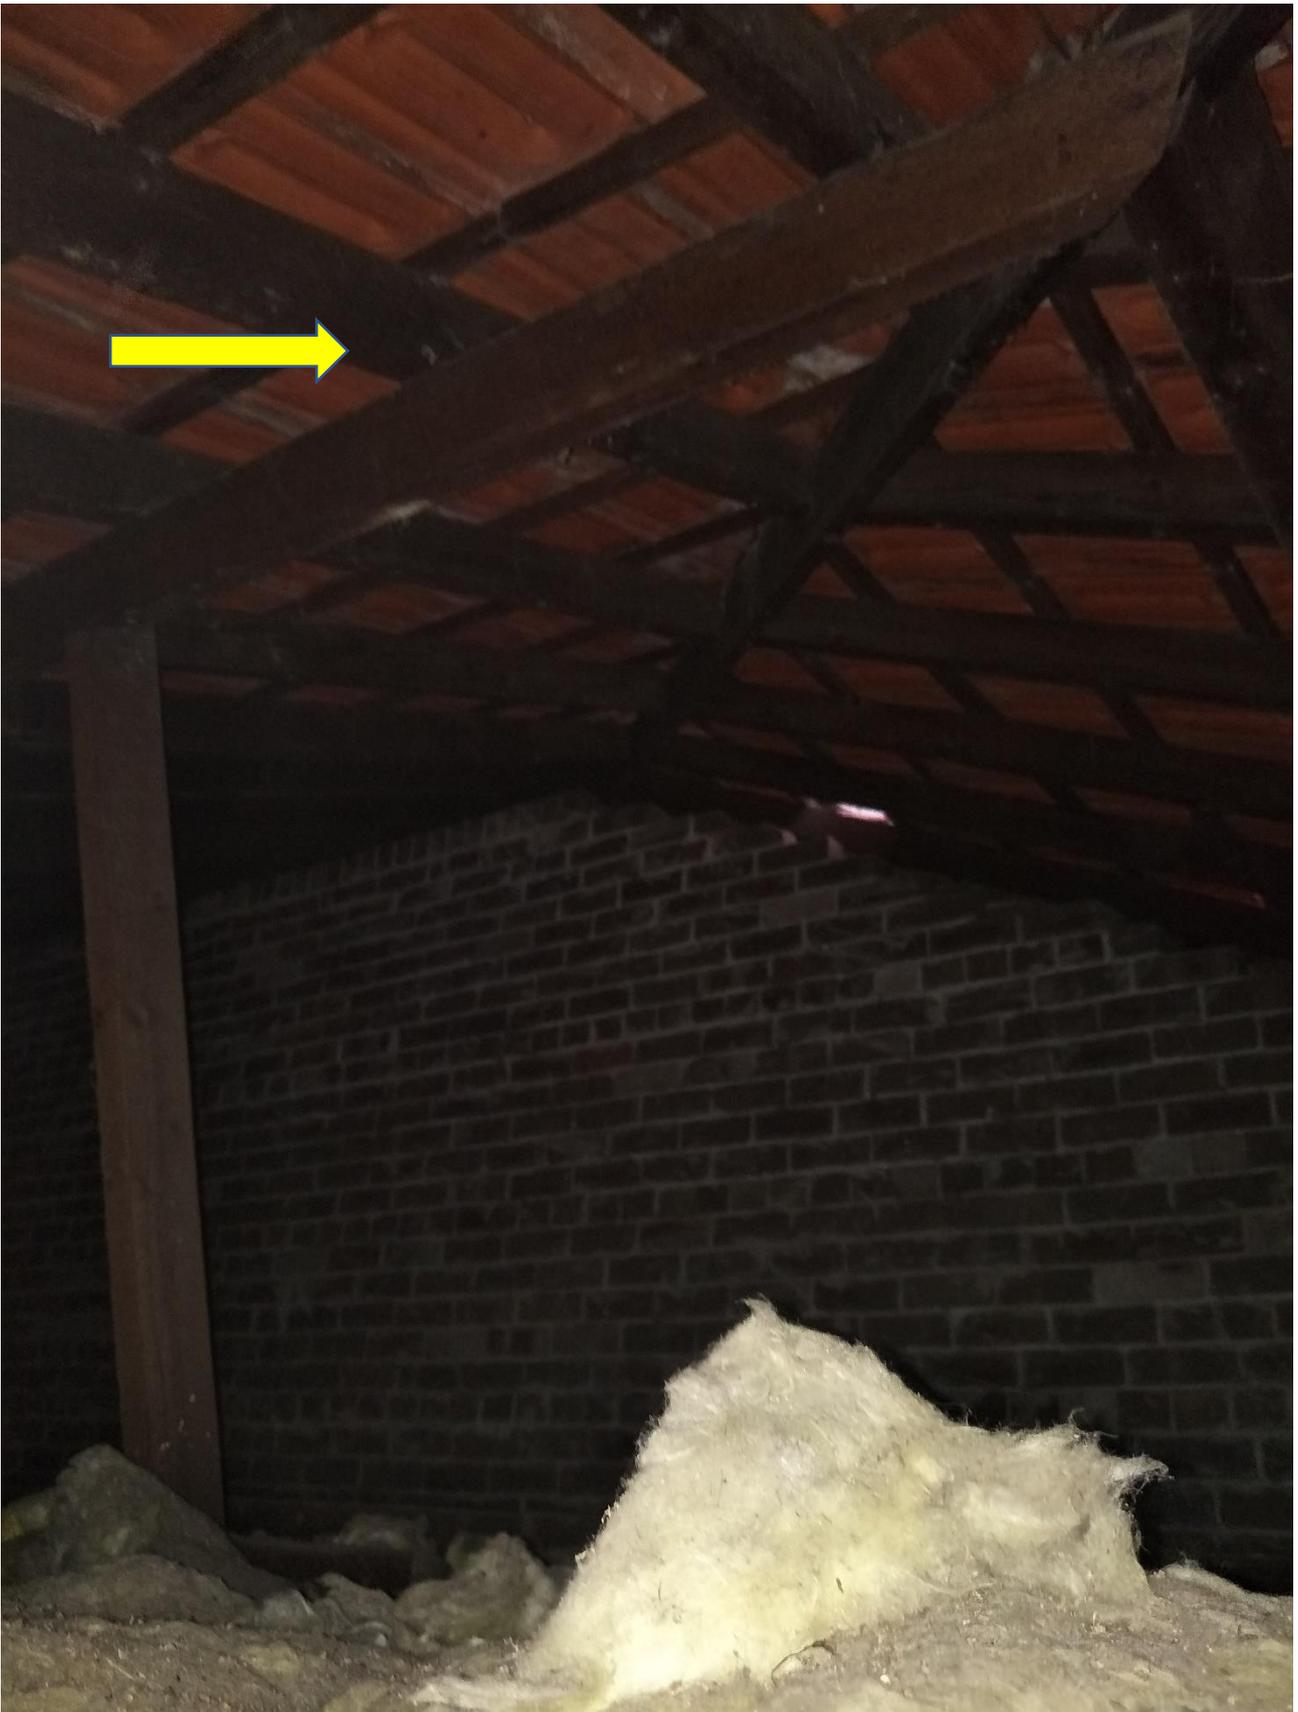
Figure 5 no evidence of sarking observed in the roof, this is common with homes of this era.

Sarking: Defects/Safety Hazards found were no sarking observed ,common with homes of this era.

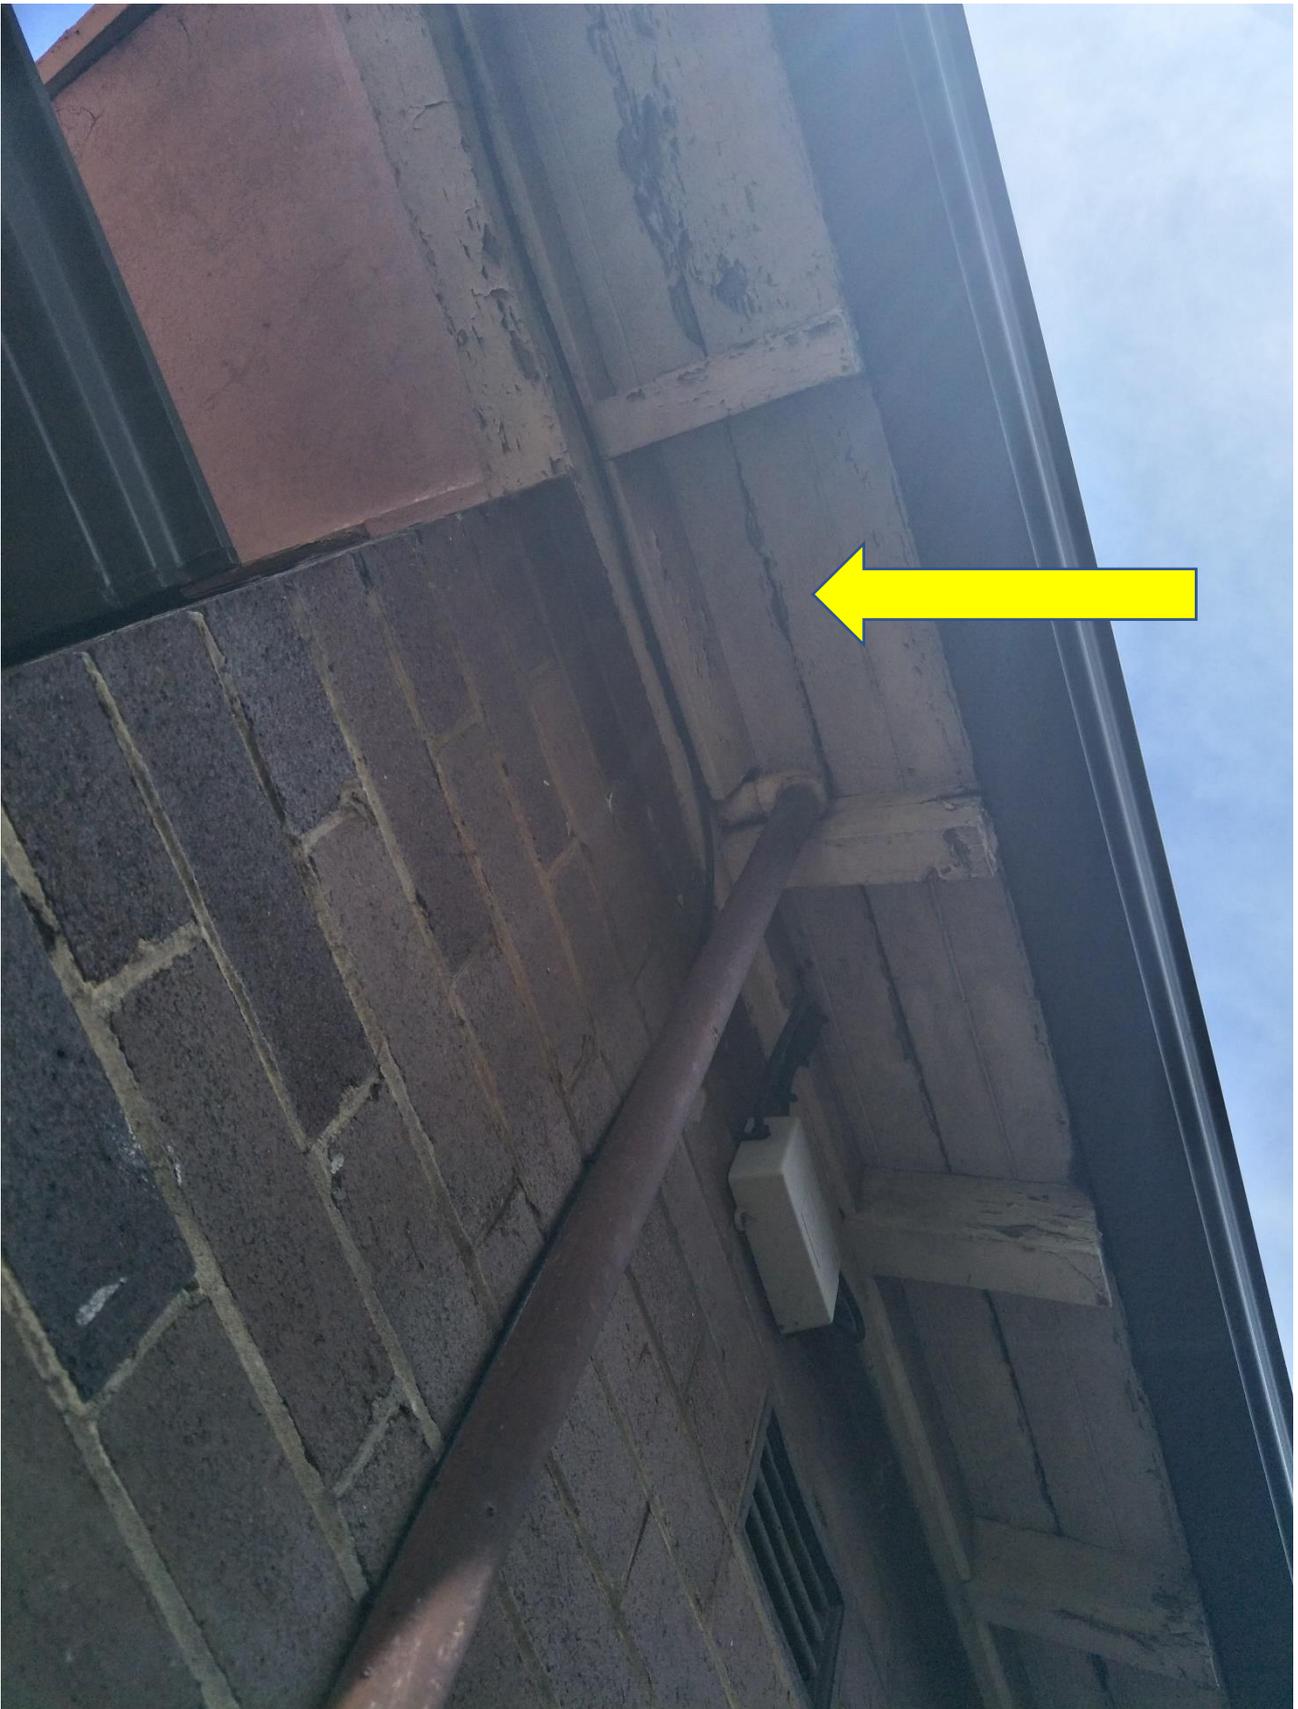
Figure 6 all eaves and exterior timber work requires repointing ; this is a general maintenance item. Engage a repointing contractor.

Eaves: Defects/Safety Hazards found were requires repainting and some wood rot repairs, engage a carpenter and painting contractor.

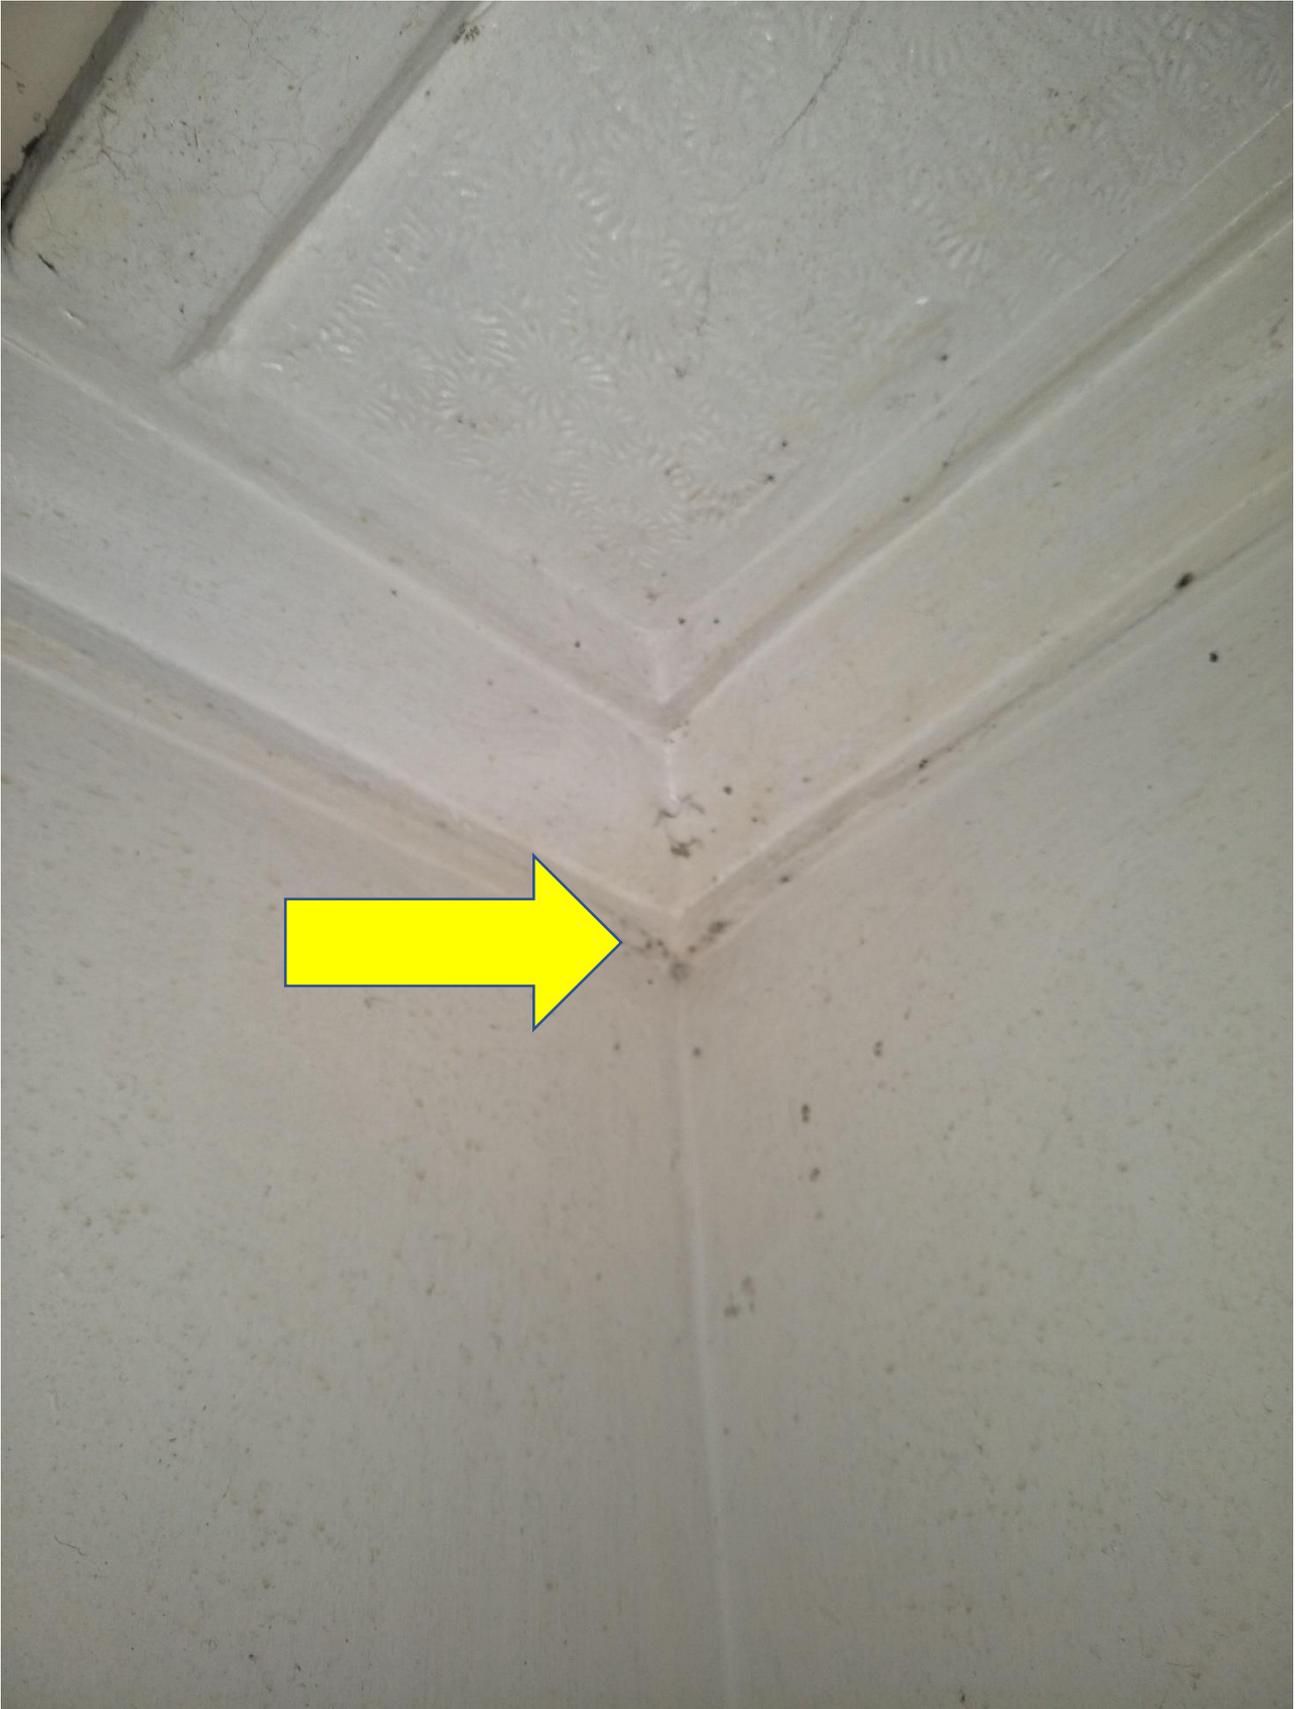
Bathroom: No Defects/Safety Hazards found. requires a general upgrade mould is evident on the ceiling.

Figure 7 evidence of mould located in the shower location due to inadequate ventilation.

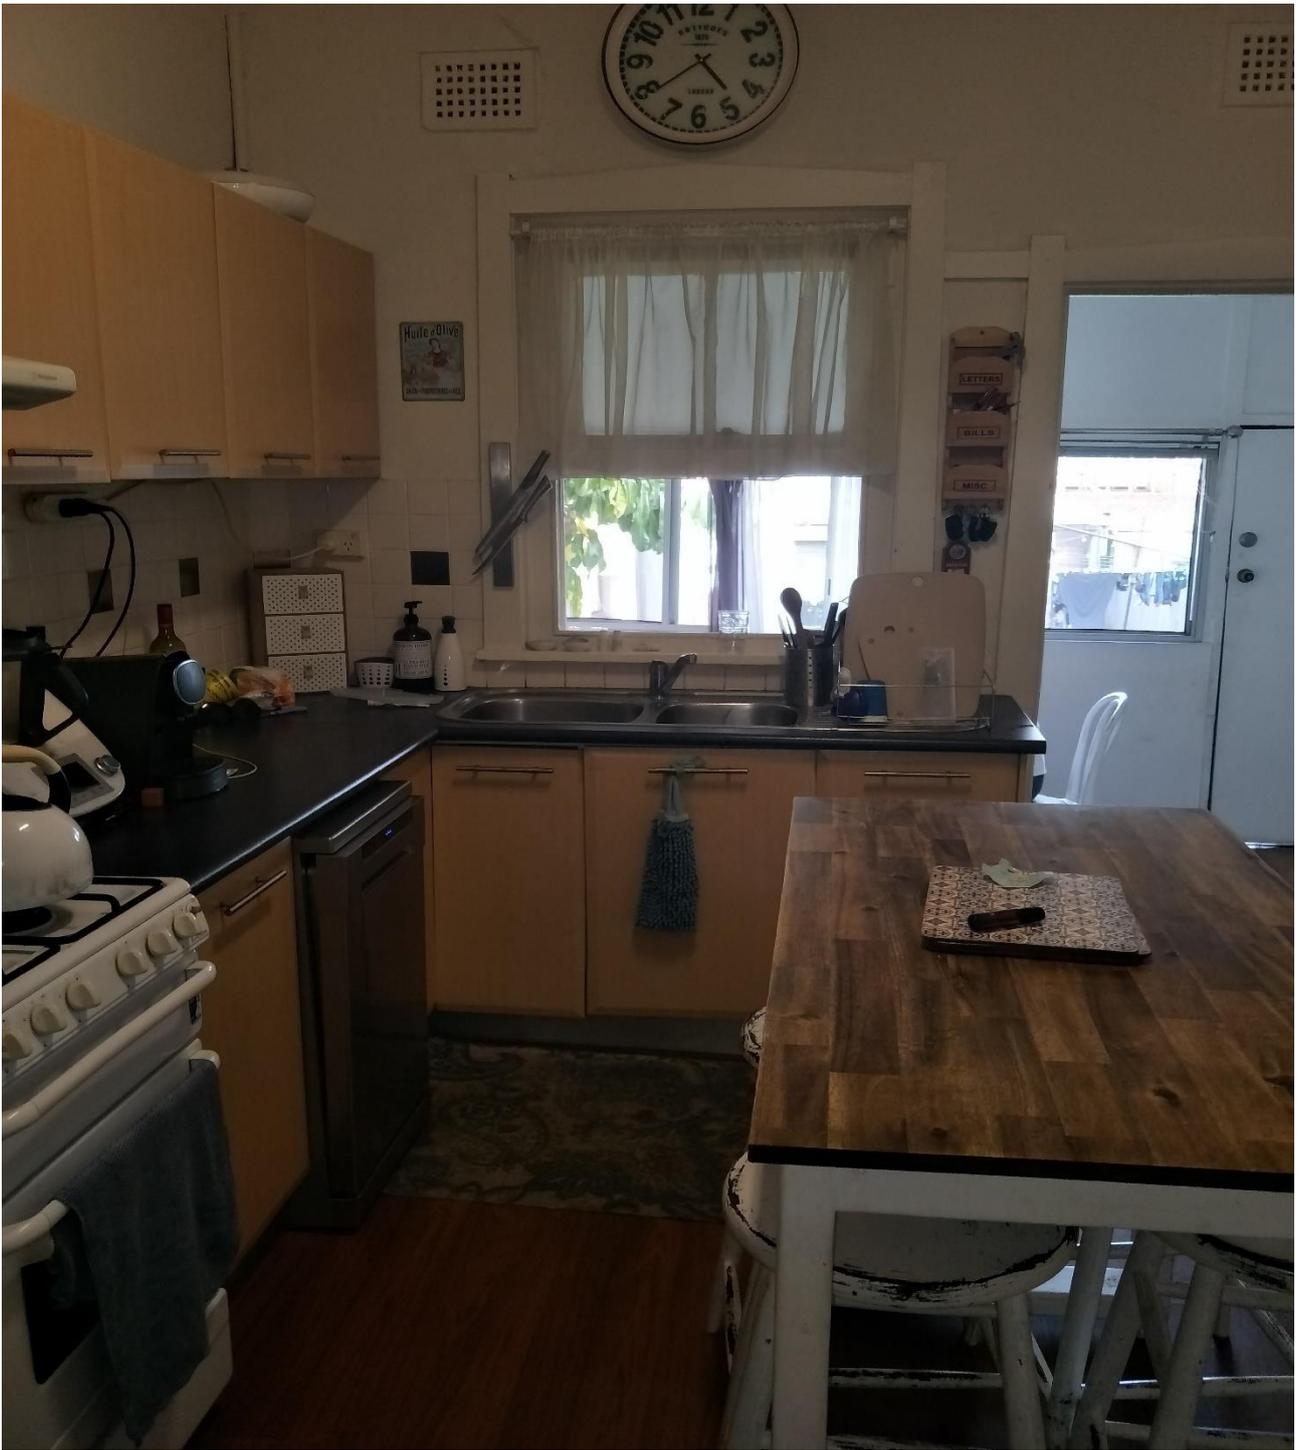
Kitchen: this requires repainting general maintenance and an upgrade.

Figure 8 the kitchen is in working condition and requires an upgrade.

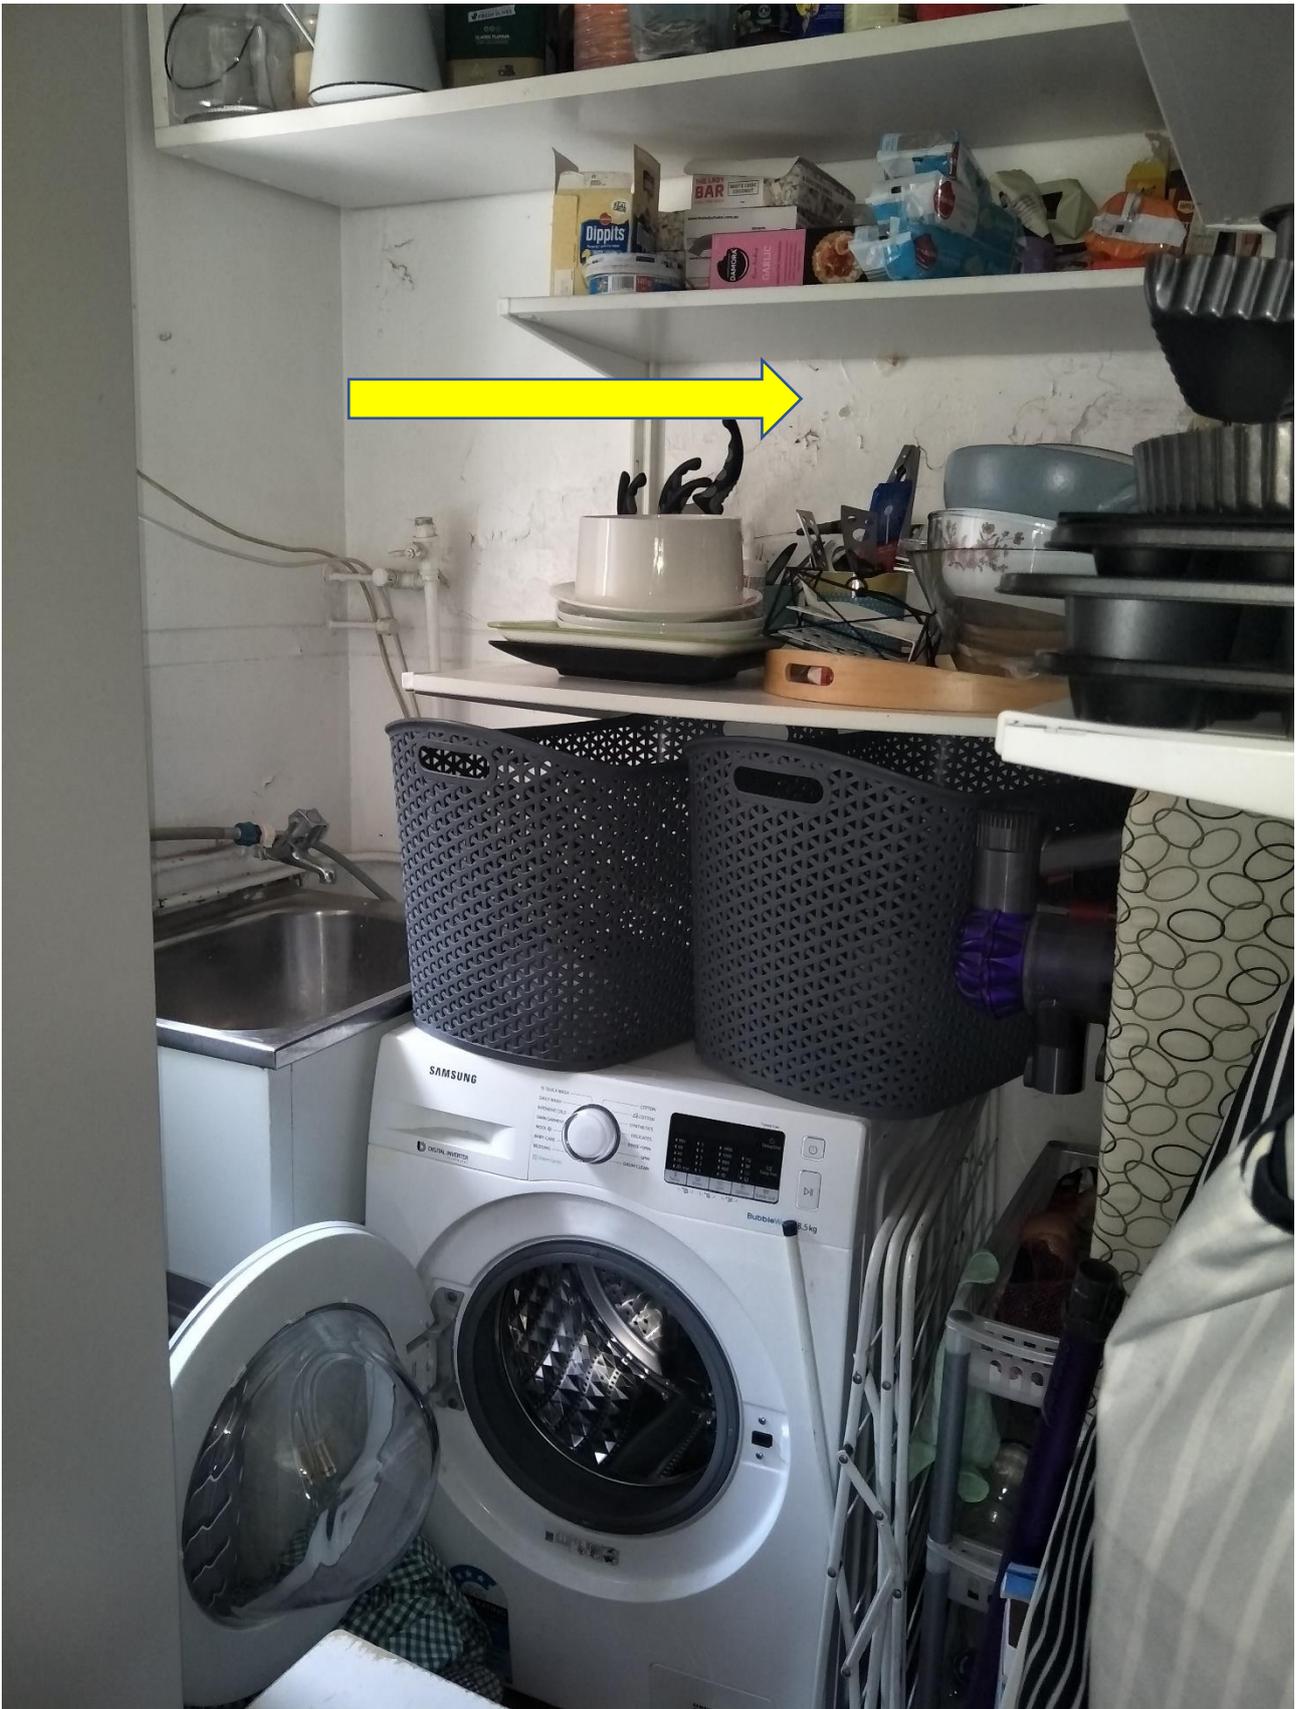
Laundry: No Defects/Safety Hazards found. this requires repainting general maintenance and an upgrade. Walls appear to be damp affected near the shower wall location, possible leaking shower.

Figure 9 the walls to the laundry have evidence of water ingress from the shower located directly adjacent to the location.

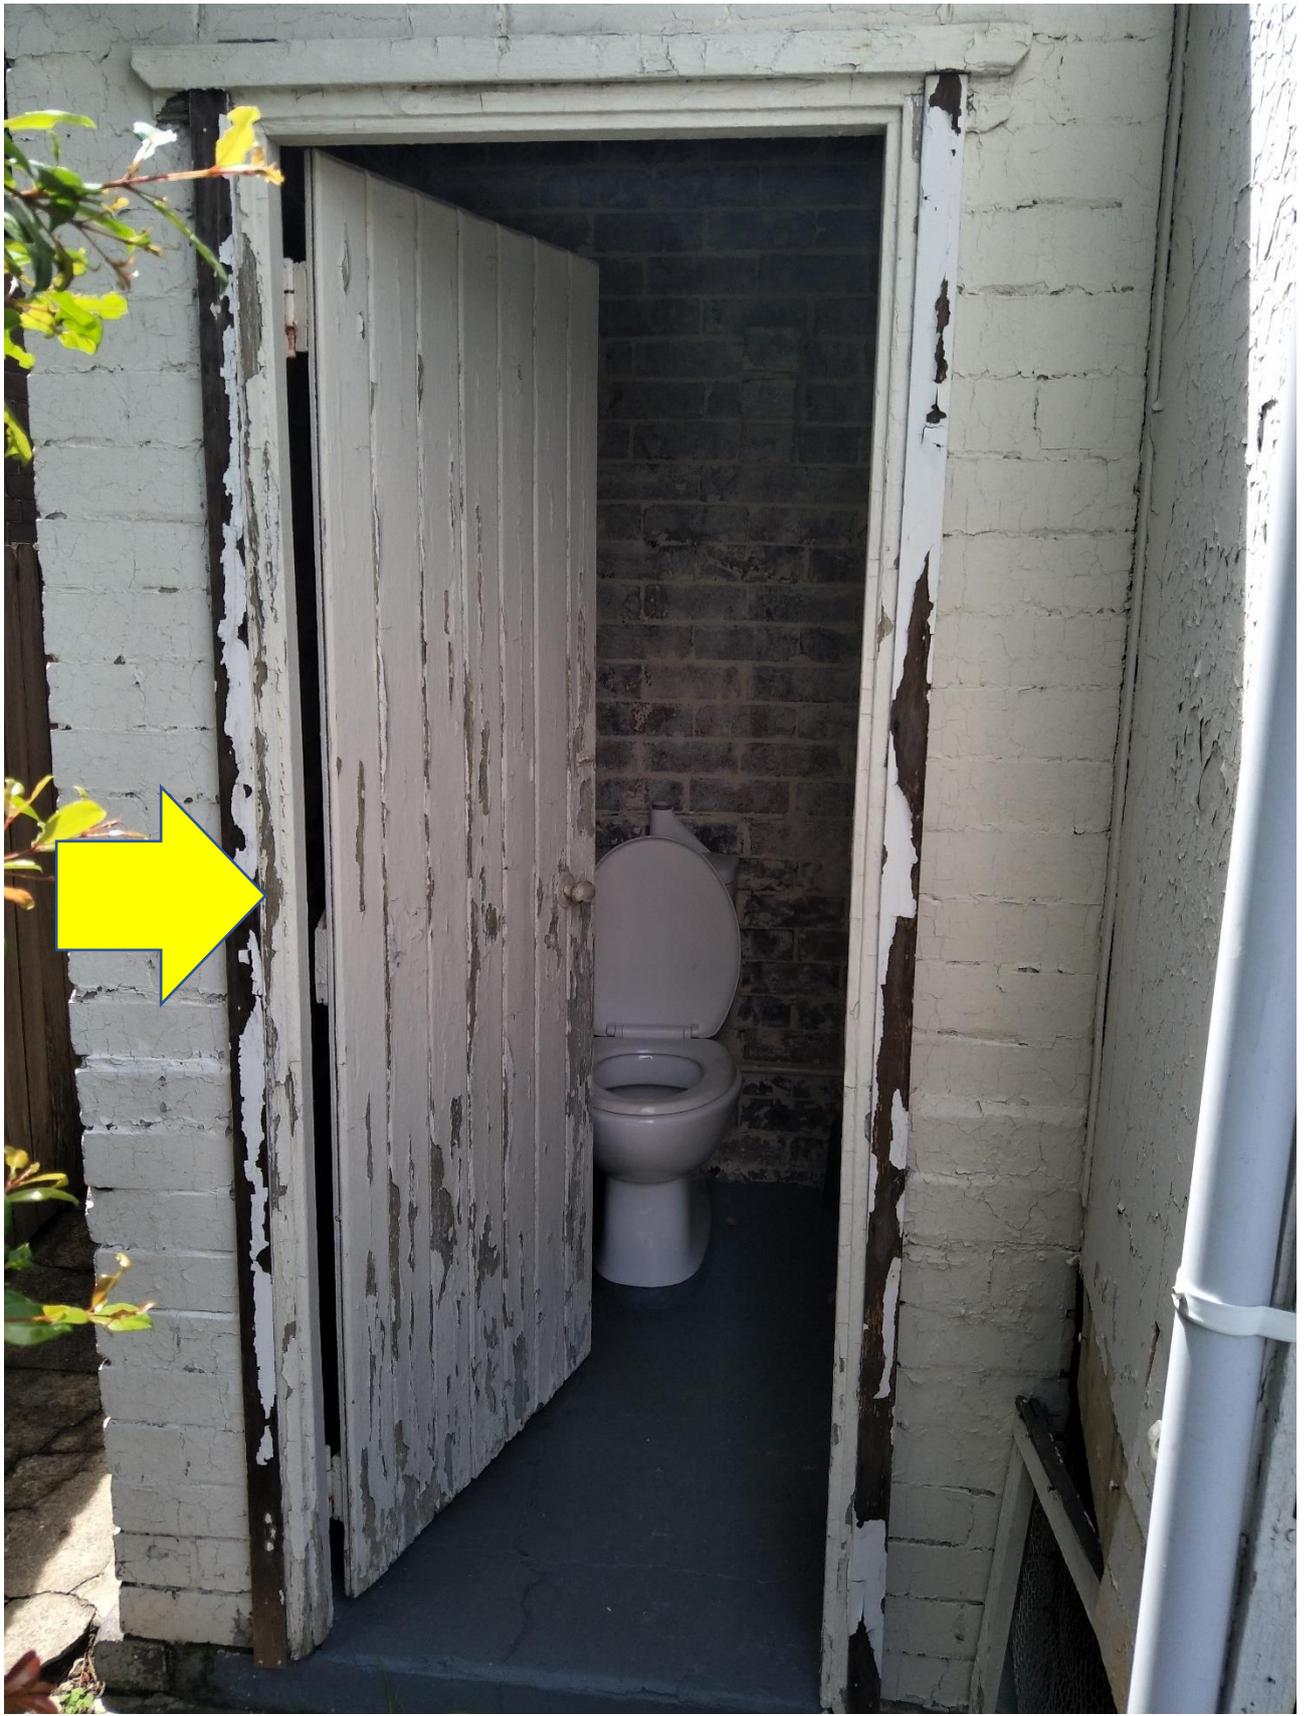
4.

Figure 10 timber work around the house requires painting and maintenance. Engage a carpenter and painting contractor to rectify.
