Pre-Purchase Inspection - Residential Building Report (Except ACT)

Complies with Australian Standard AS 4349.1- 2007 Inspection of Buildings Part 1:
Pre-Purchase inspections – Residential buildings – Appendix “C”

Account to: Sample report
Phone: Sample
Address: Sydney

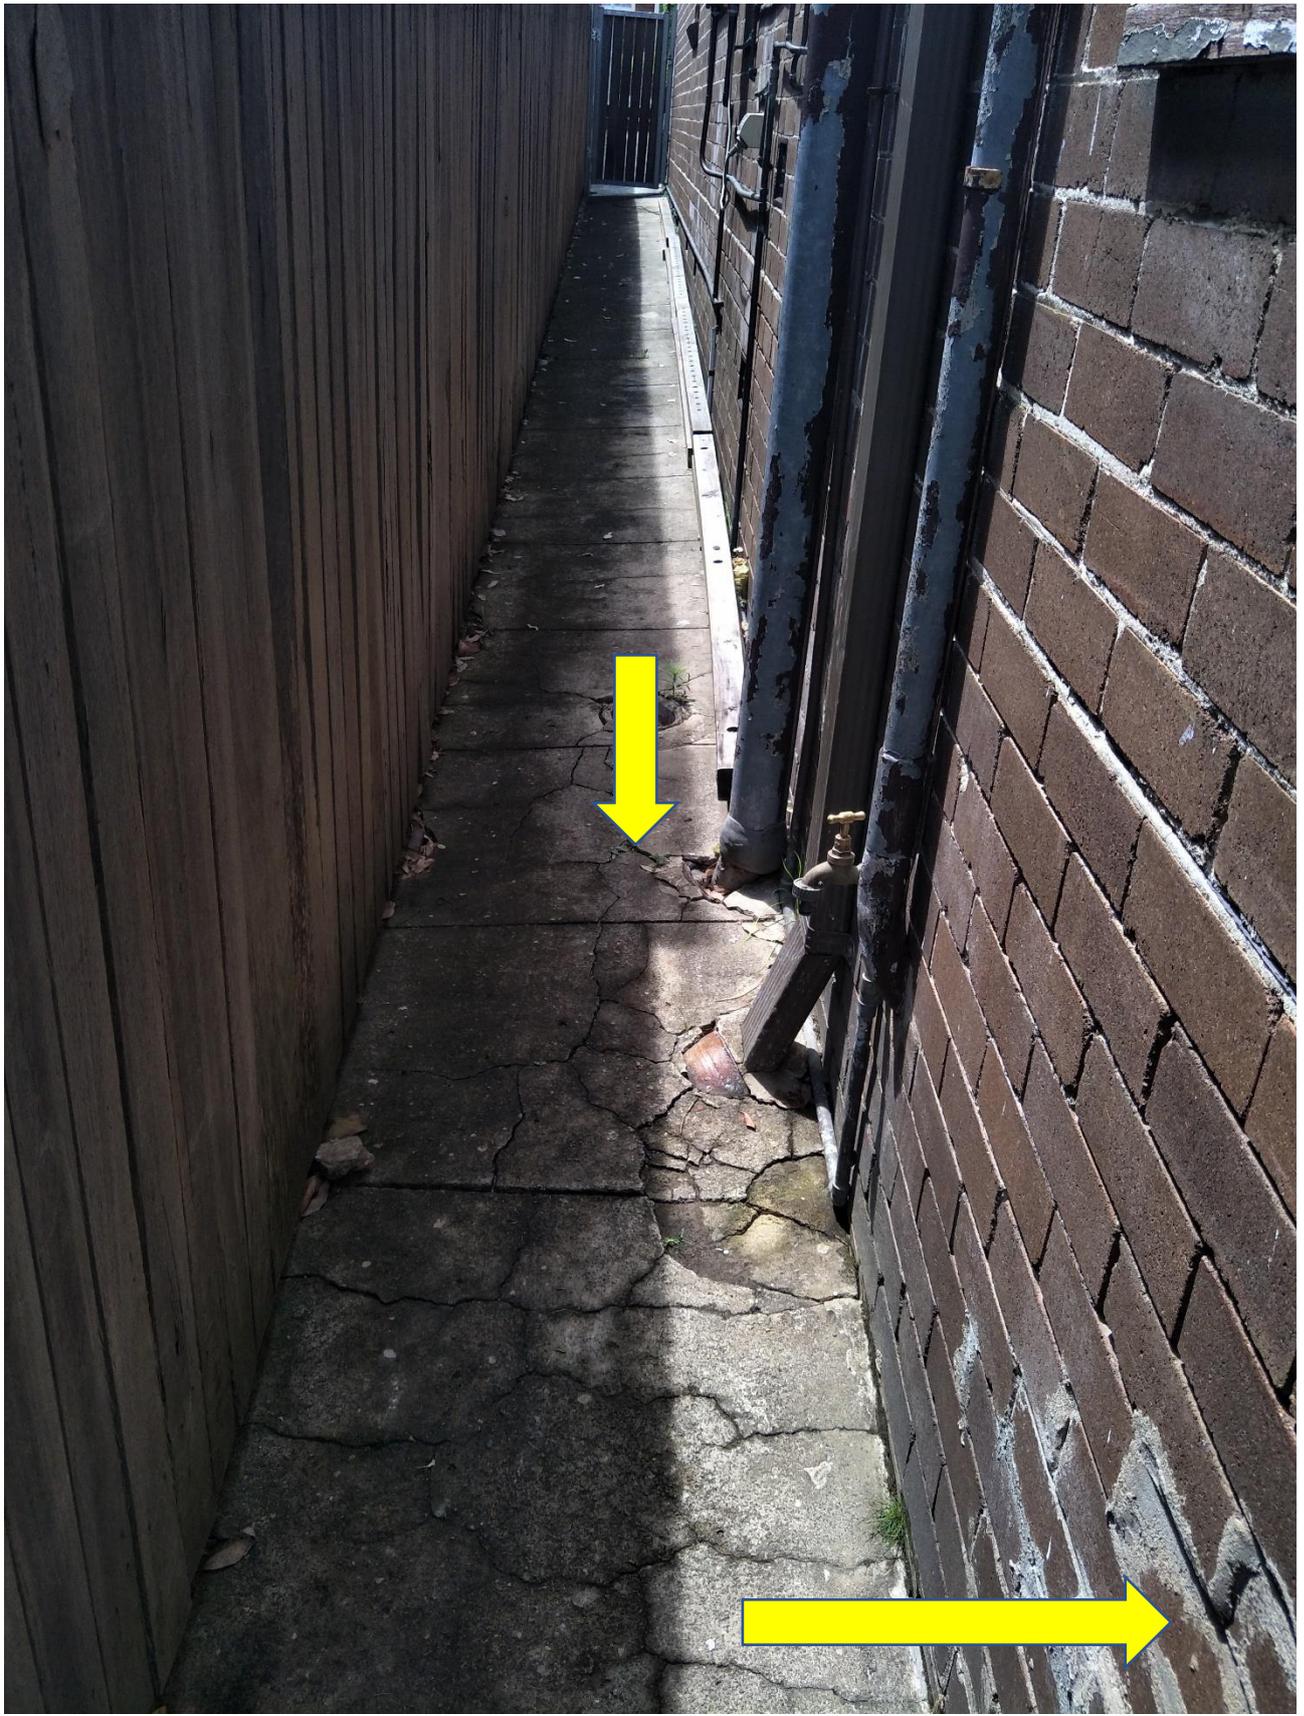
5.

Paths: Defects/Safety Hazards found were paths have cracks consistent with houses of this era and the method of construction used.

Figure 11 pathways have cracks, these are common with this era. The pathway requires total replacement. The pointing around the brick walls requires repointing engage a pointing contractor.

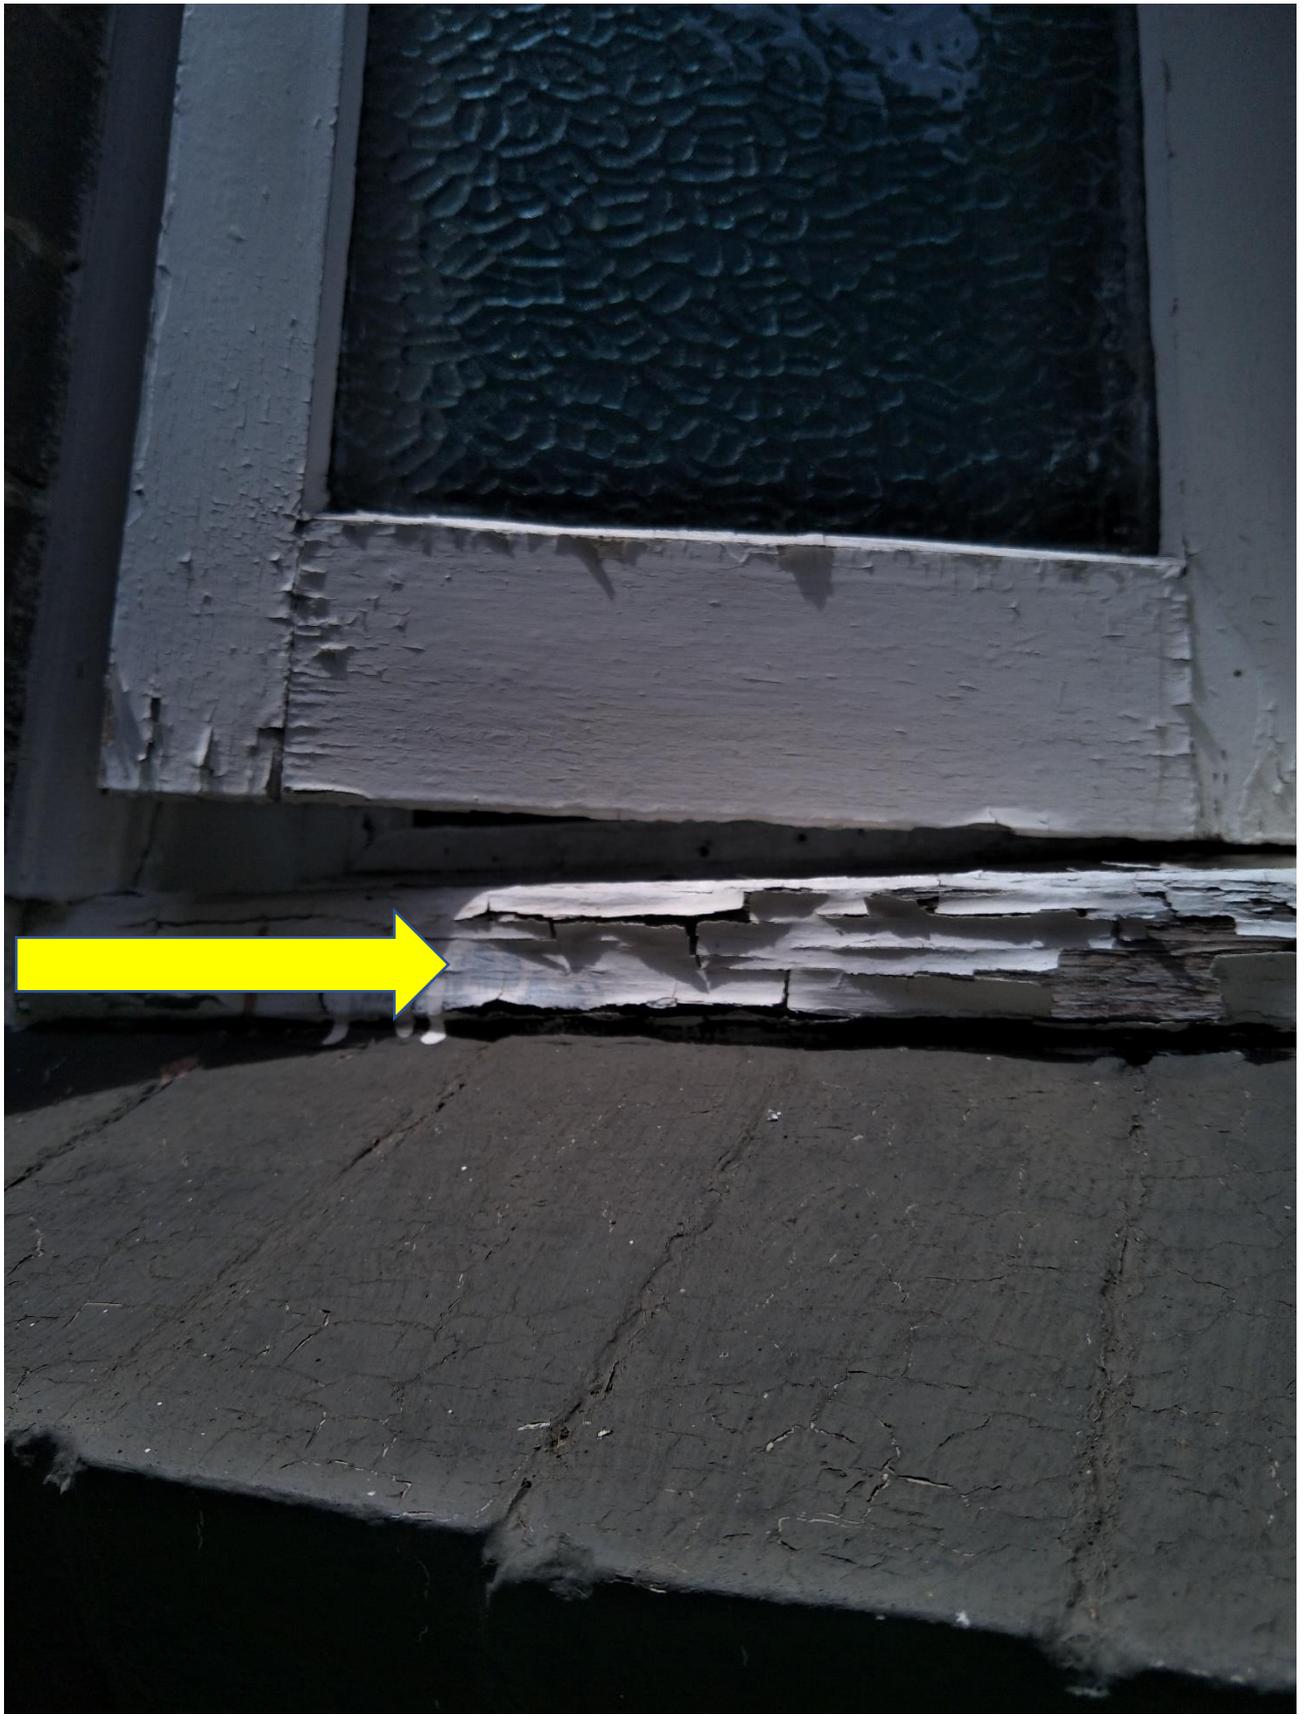
6.

Figure 12 timber work around windows is in a dilapidated state.

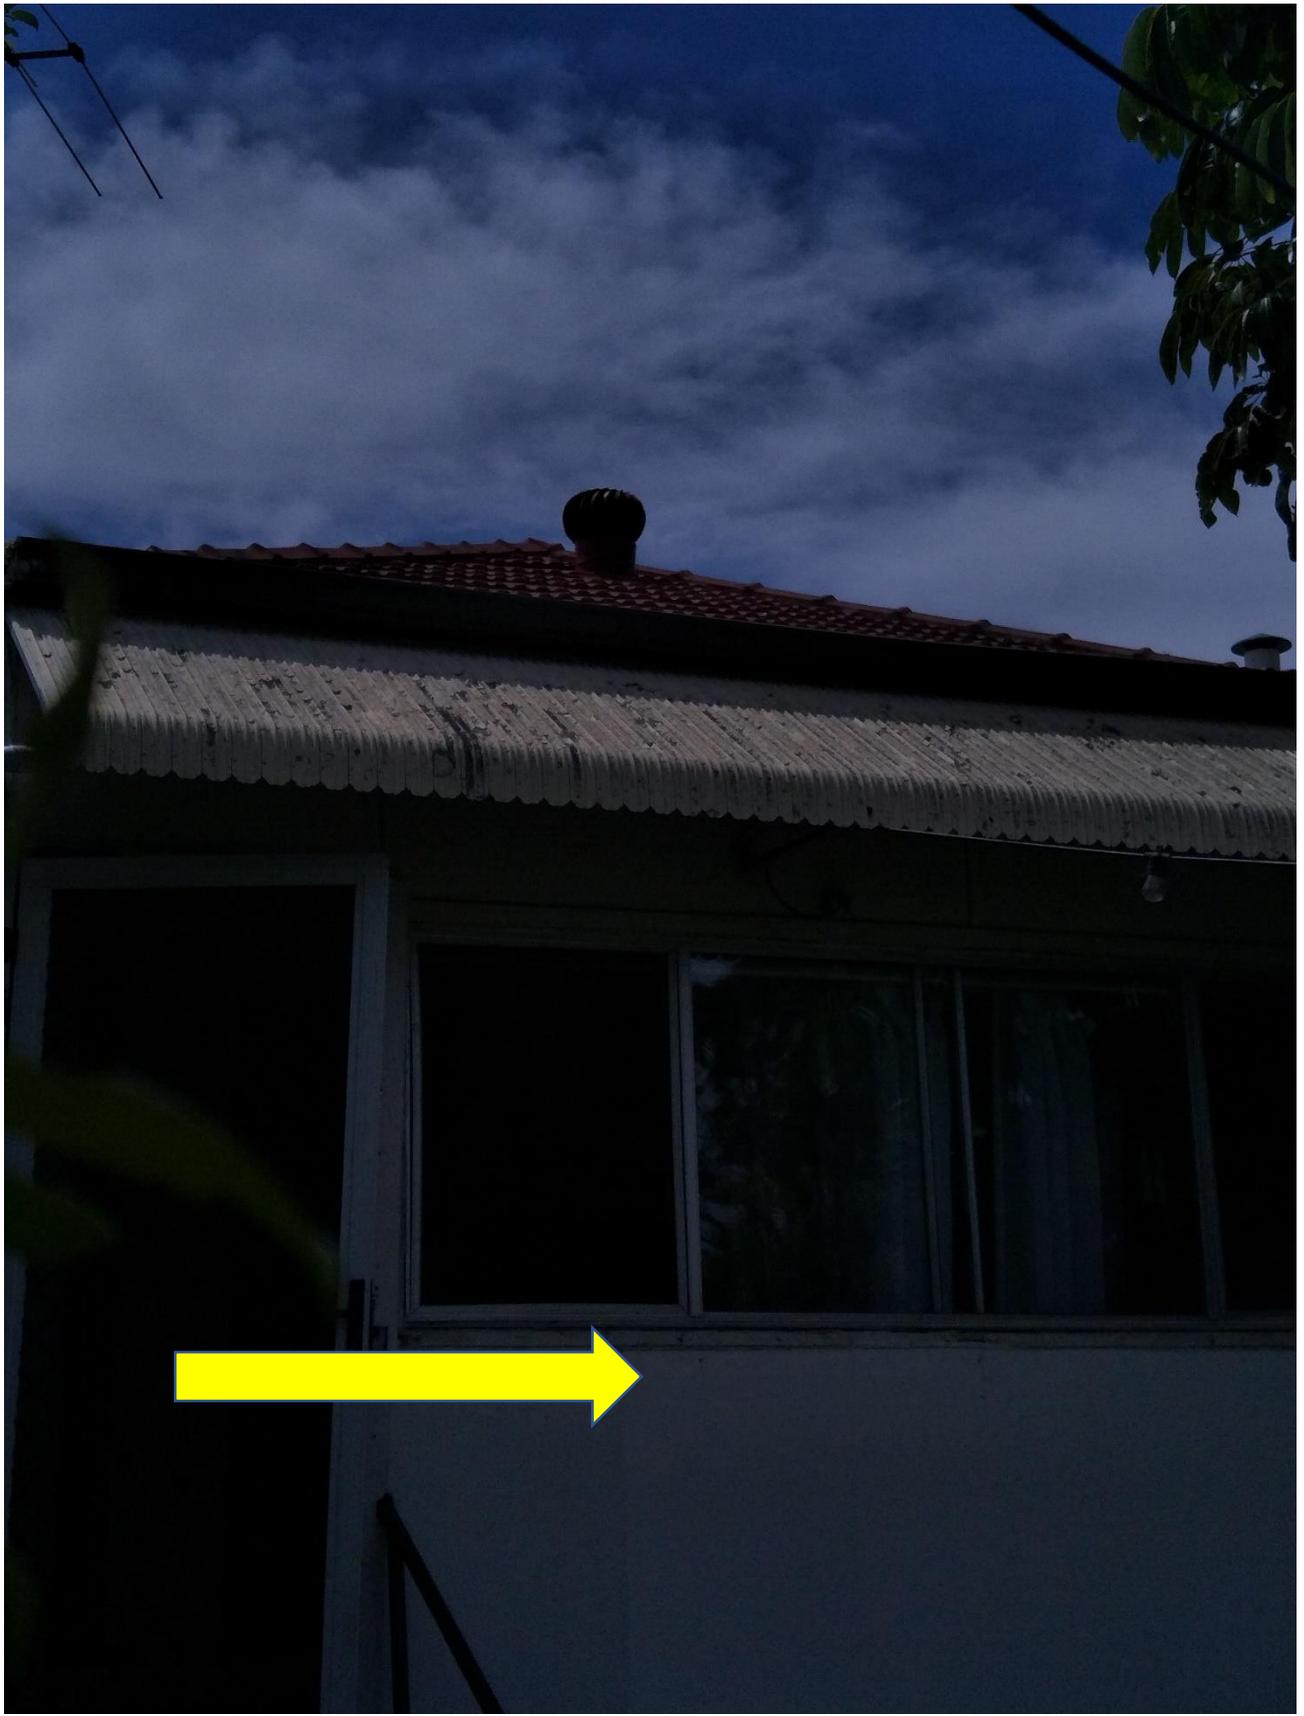
7.

Figure 13 the rear panel has evidence of possible asbestos on the rear wall lining this requires further testing.

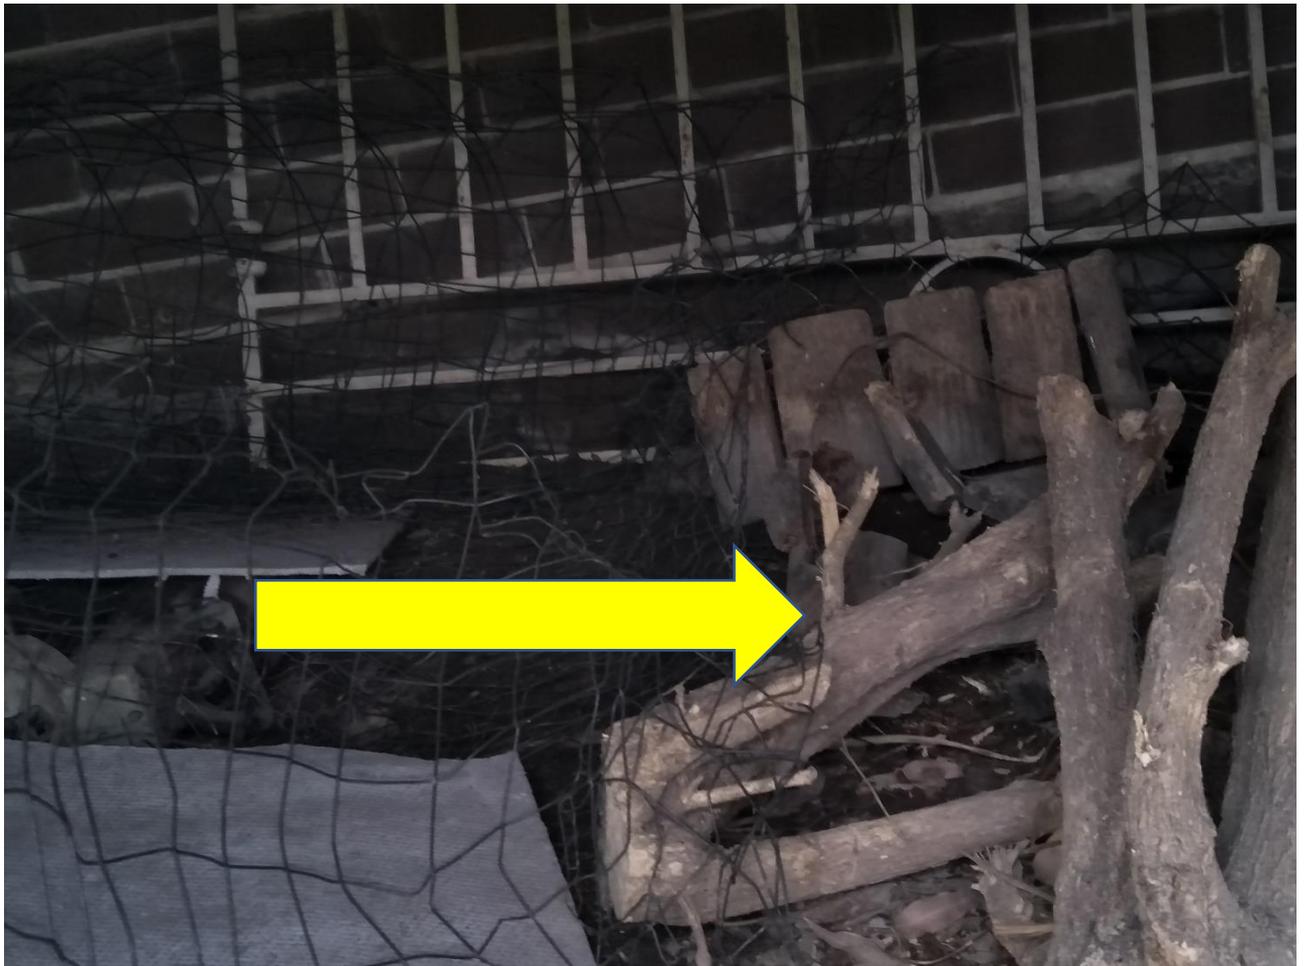
8.

Figure 14 stored timbers in the subfloor require removal as this may increase the risk of termite attack.

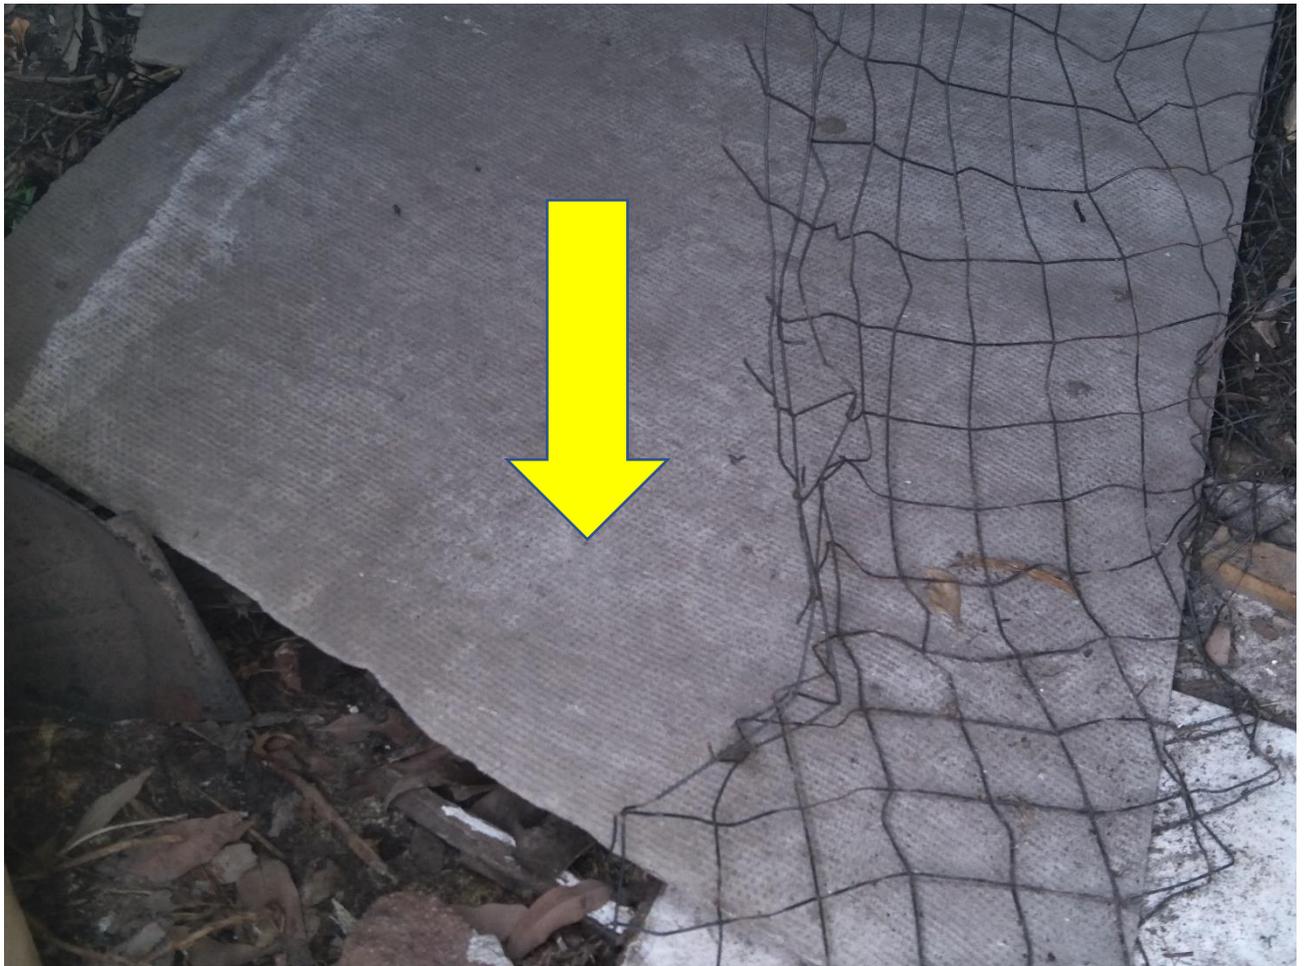
9.

(a) Areas NOT Inspected Including Reason(s) were: subfloor has asbestos at entrance and was a safety health hazard. **Roof insulation.**

Figure 15 material that appears to be asbestos is found in the subfloor making it a safety risk to crawls where there may be asbestos, it is recommended the asbestos be removed and disposed of.

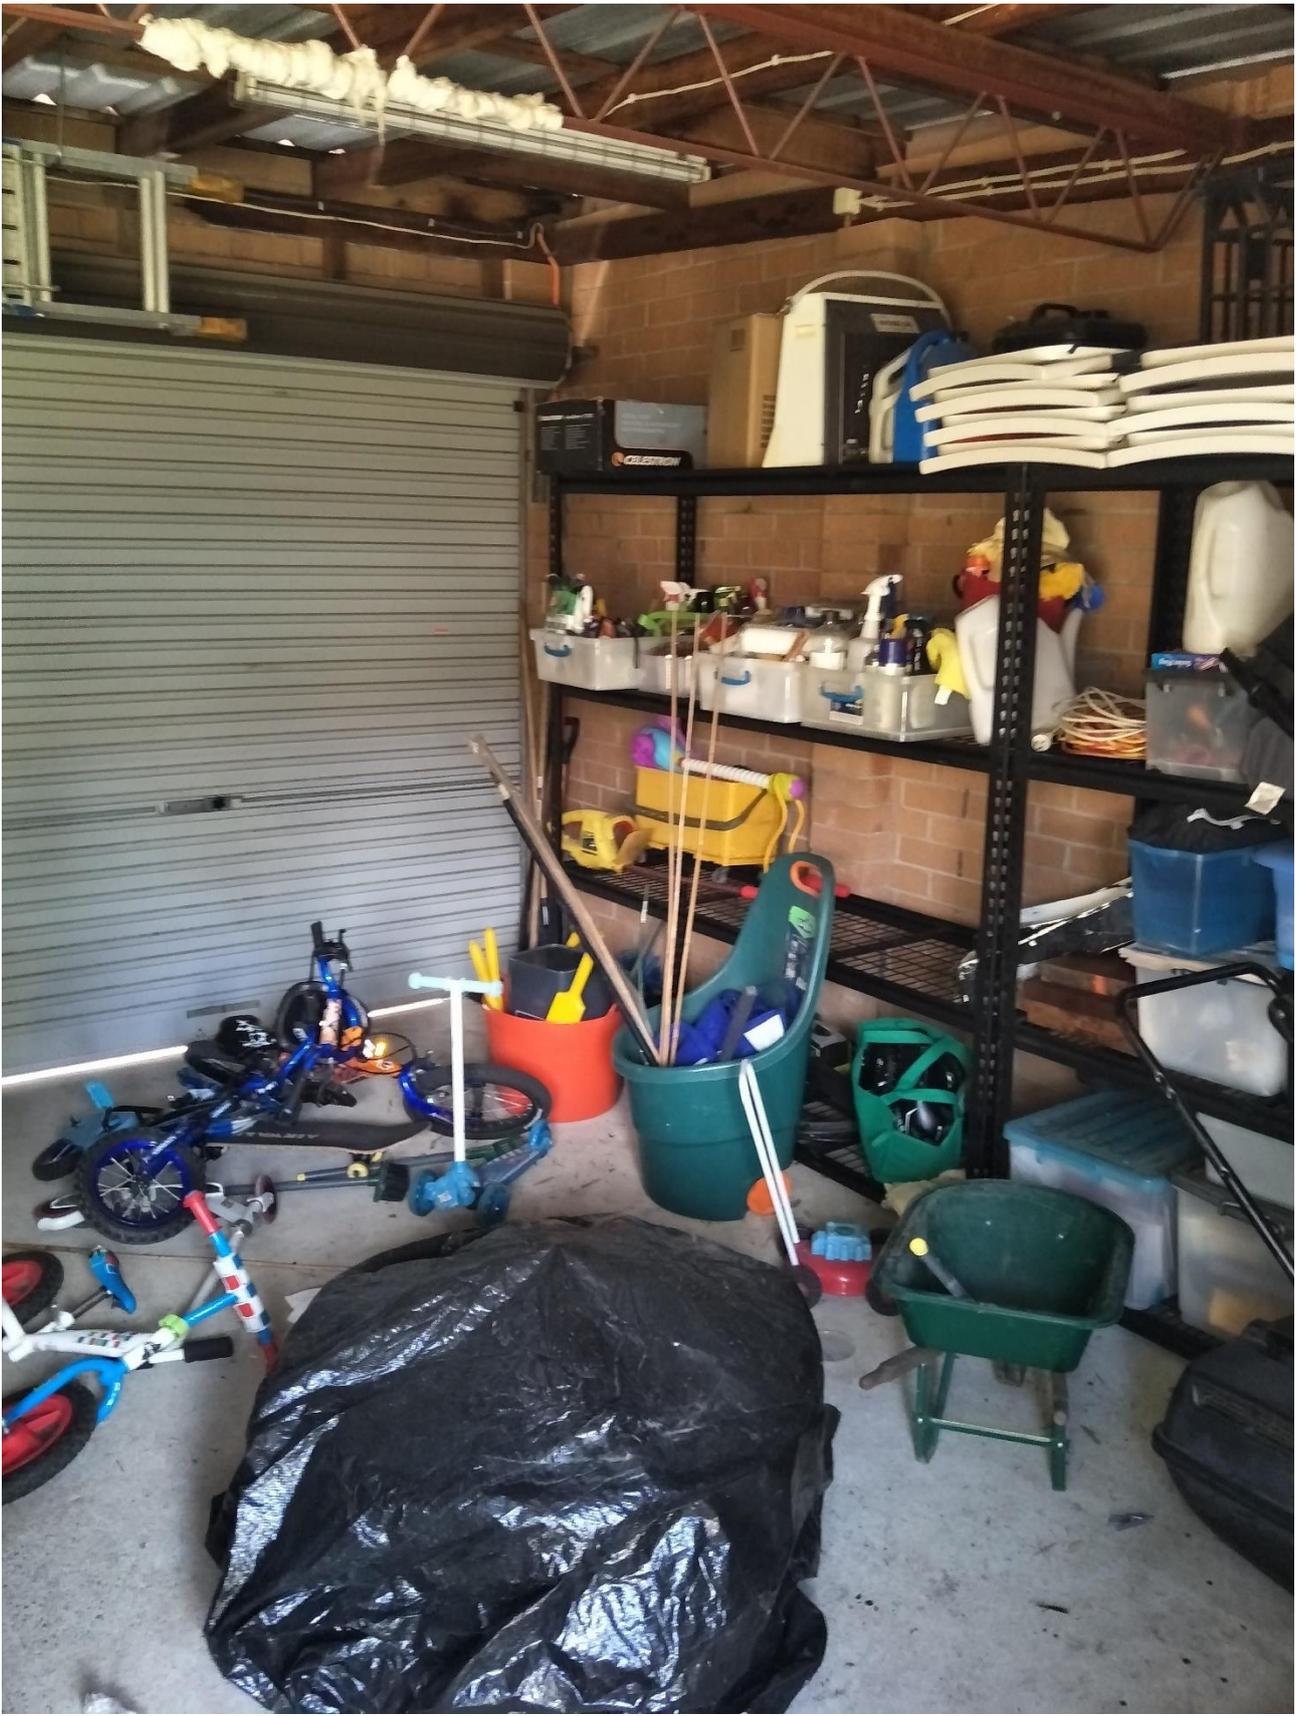
Figure 16the garage had stored items restricting access for the inspection.
